## Accessibility Audit

**Airedale Junior School**  
Fryston Road  
Airedale  
Castleford  
WF10 3EP

Date 08/10/2015

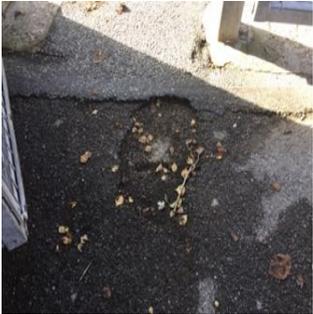
<p>Photo 5</p> </div>		
<p>1.5 - Is the location of the site clearly identified from the street? Visual clues and sufficient landmarks to aid orientation?</p>	<p>C</p>	<p>There is a lack of on street signage on approach to the school.</p>

<p>Photo 4</p> </div> </div>		
<p>1.4 - Surfaces even and slip resistant? Is paving flush with no cracks or gaps that could trap the wheels of a wheelchair?</p>	<p>Yes / N/A</p>	<p>Various parts of the external routes have tripping hazards identified such as just before the right side gate.</p>

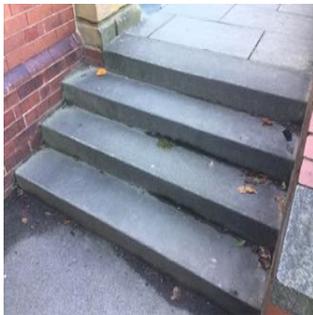
Photo 25

4.6 - Nosings readily identifiable? If nosings are painted, is the paint still durable with no wear and tear?	B	The external steps do not have suitable colour contrast provided to the edge of the step nosings. The steps up to the mobile building require repainting. The left side fire exit steps from the mobile building does not have the top step highlighted.

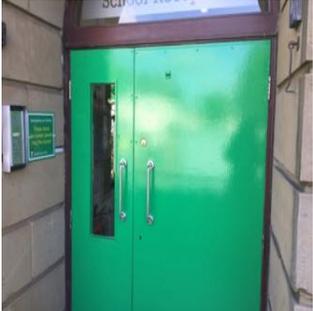
<p data-bbox="264 1236 353 1259">Photo 34</p>

5.5 - Can people each side of the door, either standing or seated, see each other and be seen? If the entrance is solid, is this due to security concerns?	B	The entrance has a vision panel on the left side but not on the actual entrance. This could result in a potential collision hazard from someone on the inside opening the door onto someone outside.

5.5	The entrance has a vision panel on the left side but not on the actual entrance. This could result in a potential collision hazard from someone on the inside opening the door onto someone outside.	Provide a vision panel to prevent a potential collision hazard.  BS8300 - Entrance doors and lobby doors should have viewing panels to alert people approaching a door to the presence of another person on the other side.	<b>M</b>

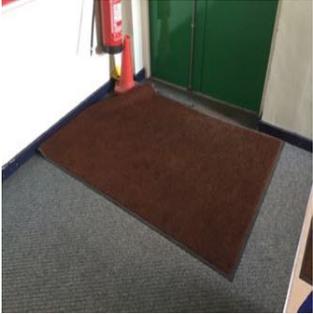
Question	Response	Details
5.10 - Weather mat of firm texture and flush with floor?	D	At the next refurbishment for the site, consider installing recessed mats rather than the current loose ones to minimise the potential tripping hazard. At another site we've surveyed, similar mats to these were provided and someone tripped up on one of the loose corners.

5.10	At the next refurbishment for the site, consider installing recessed mats rather than the current loose ones to minimise the potential tripping hazard. At another site we've surveyed, similar mats to these were provided and someone tripped up on one of the loose corners.	At the next planned refurbishment for the site, consider installing recessed mats which are flush with the surrounding flooring.  Refer to BS8300 - any matting should either have its surface level with the adjacent floor finish or, if surface laid, be of a type that has a rubber backing and chamfered edges. if, in exceptional circumstances other types of surface laid mats are used, they should be securely fixed to the floor at their edges and at any joints, to avoid the risk of tripping or slipping.	<b>M</b>

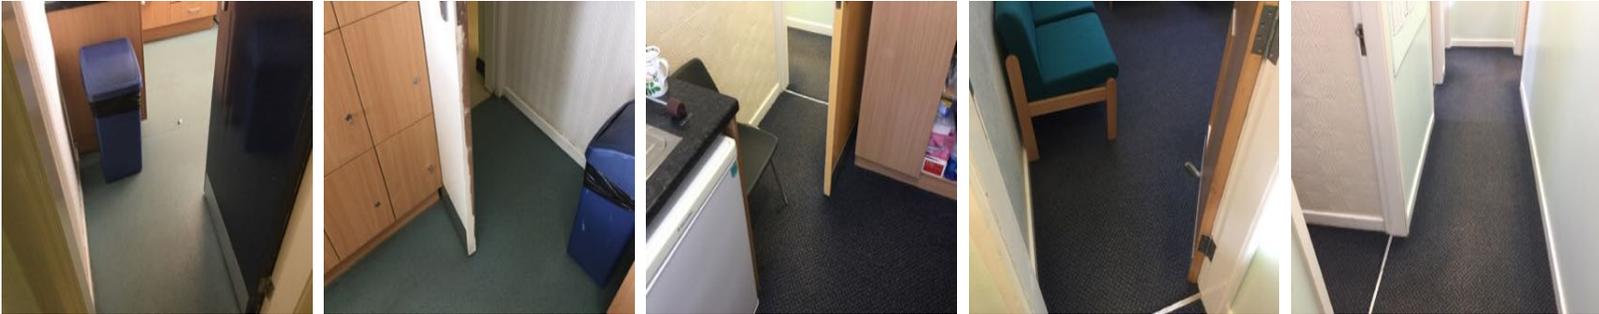
Question	Response	Details
<p>7.1 - Corridor wide enough for a wheel chair user to manoeuvre and for other people to pass? Turning space for wheel chair users?</p>	<p>A</p>	<p>The approach into the staff room is too tight to accommodate wheelchair users due to the way the door is hinged and the positioning of the lockers.</p> <p>The staff corridor near the reception area may be difficult for wheelchair users to negotiate as there is a limited turning approach into the rooms.</p> <p>Wheelchair users are likely to struggle to access the small kitchenette near the Headperson's office due to the positioning of a storage cabinet and chair.</p> <p>Wheelchair users may struggle to access the Headperson's office due to the positioning of the first chair.</p>

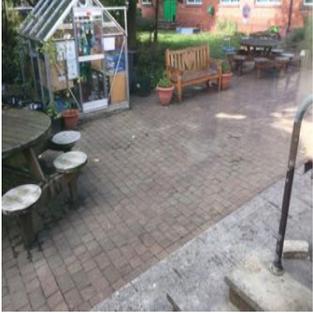
<div style="margin-left: 10px;"> <p>Photo 48</p> </div> </div>

Question	Response	Details
7.3 - Are all key facilities within the school accessible for all users? Where there are facilities not available are there alternative means of access procedures in place?	A	There is no step free access into the central courtyard and this could be considered discriminatory. It is recommended that a ramp be constructed.
<div style="display: flex; align-items: center;">

7.3	There is no step free access into the central courtyard and this could be considered discriminatory. It is recommended that a ramp be constructed.	<p>It is recommended that a ramp be constructed to allow step free access to the central courtyard.</p> <p>The ramp should have the lowest practical gradient within the range 1:20 to 1:12</p> <p>Landings should be provided at the foot and head of the ramp, they should be at least the width of the ramp and not less than 1500 mm long, clear of any door swing or other obstruction.</p> <p>BS8300 compliant handrails should be provided to both sides which are of an oval profile, be well contrasted and not cold to touch.</p>	<b>ST</b>

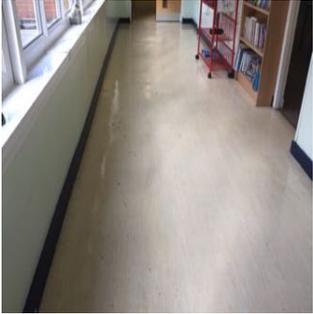
<p data-bbox="264 759 349 778">Photo 51</p>

Question	Response	Details
7.6 - Floor surfaces slip-resistant? Bright, boldly patterned floors avoided?	Yes / N/A	Throughout the school the floor surfaces appear to be slip-resistant. There does not appear to be any bright and boldly patterned floors that could potentially cause confusion for people with impaired vision. However the vinyl flooring throughout gives off a minor shine which could make people with impaired vision apprehensive as it could appear to be a wet surface.

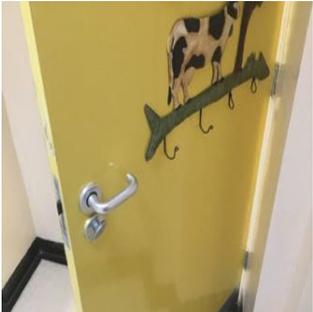
Question	Response	Details
<p>13.5 - Door controls, lock and light switch easily reached and operated? Is there a grab rail to the inner face of the entrance?</p>	A	<p>The door lock is not compliant to BS8300 and there is no grab rail to the inner face of the entrance.</p> <p>Also refer to 8.6, The accessible WC entrance is stiff to close.</p>
<div style="display: flex; align-items: center;">

13.5	<p>The door lock is not compliant to BS8300 and there is no grab rail to the inner face of the entrance.</p> <p>Also refer to 8.6, The accessible WC entrance is stiff to close.</p>	Include as part of the refurbishment, refer to recommendation 13.1.	<b>M</b>

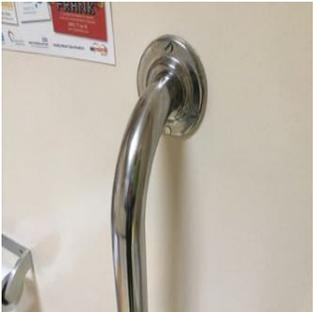
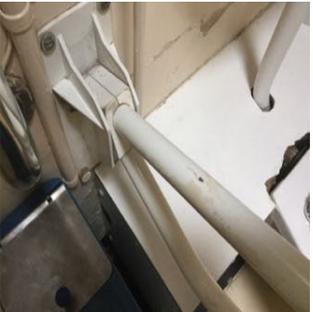
<div style="margin-left: 10px;"> <p>Photo 78</p> <p>Photo 79</p> </div> </div>		
<p>13.8 - Is there a back rest provided to the toilet pan?</p>	A	<p>There is no backrest to the rear of the toilet pan.</p>

<div style="margin-left: 10px;"> <p>Photo 77</p> </div> </div>		
<p>13.6 - Tap appropriate for use by a person with limited dexterity, grip of strength?</p>	A	<p>Refer to above, The hand wash basin is positioned too far away from the toilet pan and the taps are dated. It is preferable to have a single lever mixer tap.</p>
<p>13.7 - Suitably designed grab rails fitted in all positions necessary to assist manoeuvring? Are grab rails suitably colour contrasted to aid people with impaired vision?</p>	A	<p>Grab rails are dated and are of a mirrored finish which is not recommended. The drop down rail was deemed to be filthy.</p>

13.7	<p>Grab rails are dated and are of a mirrored finish which is not recommended. The drop down rail was deemed to be filthy.</p>	Include as part of the refurbishment, refer to recommendation 13.1.	<b>M</b>
