## Accessibility Audit

**Airedale Junior School**  
Fryston Road  
Airedale  
Castleford  
WF10 3EP

Date 08/10/2015

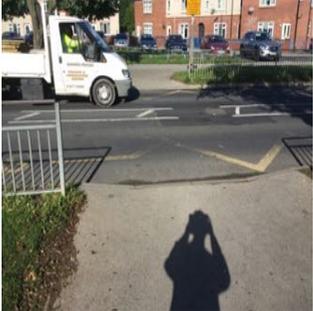
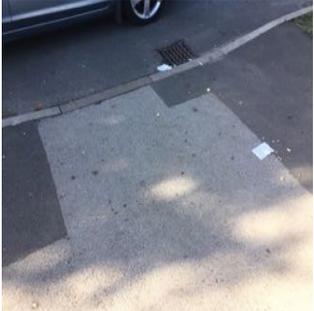
1.2 - Route free of kerbs? Do crossings on approach have tactile paving? If there are pedestrian crossings, do these have turn cones to aid people who are DeafBlind?	C	There is no tactile paving provided to the crossing points on approach to the school to aid people with impaired vision.
<div style="display: flex; justify-content: space-around;"> <div style="text-align: center;">

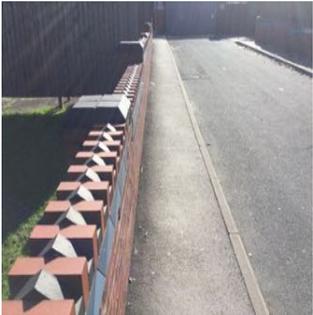
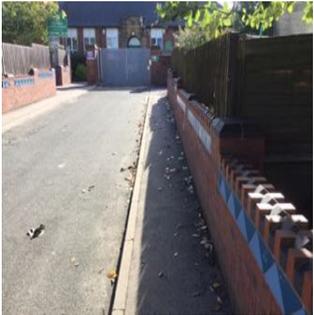
Question	Response	Details
<p>1.3 - Wide enough? If a route or pathway is narrow, is there a suitable passing place for wheelchair users? Is plantation trimmed back and are low branches avoided?</p>	<p>B</p>	<p>The pavements on approach to the school may be too narrow for some wheelchair users or mobility scooter users. This means that they may have to travel along the road and then back onto the pavement via the dropped kerbs at the gate exposing people to oncoming traffic.</p>
<div style="display: flex; justify-content: space-around;"> <div style="text-align: center;">

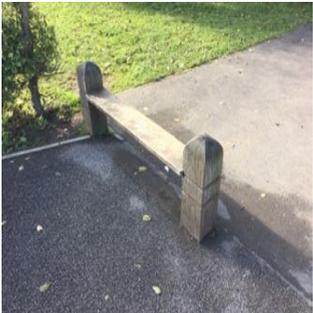
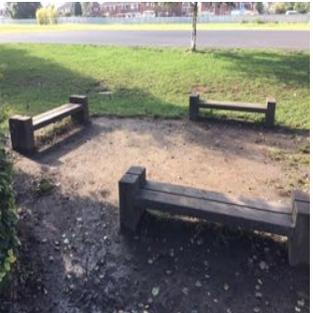
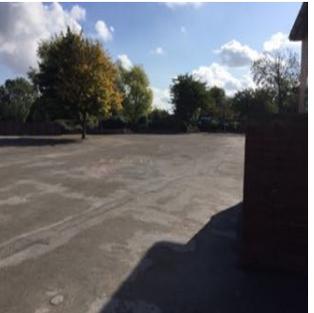
<p data-bbox="271 1366 344 1388">Photo 7</p> <p data-bbox="591 1366 665 1388">Photo 8</p> <p data-bbox="916 1366 990 1388">Photo 9</p>

1.8 - Adequate seating provided along routes? Is there suitable seating within the play areas?	C	<p data-bbox="1272 858 2063 916">There is a lack of seating with armrests within areas that parents pick up and drop off their children.</p> <p data-bbox="1272 954 1980 1011">There is a lack of suitable seating with armrests within the playground areas to aid people with ambulant disabilities.</p>

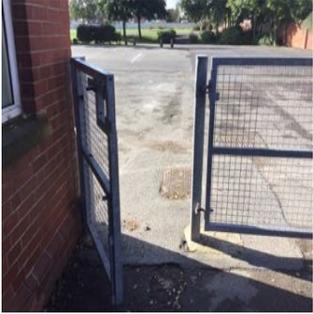
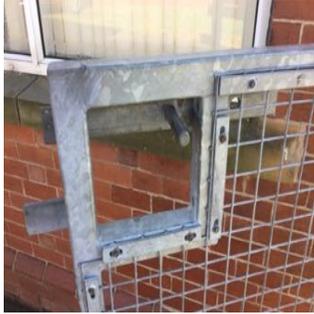
Question	Response	Details
<p>1.9 - Are entrance gates appropriately colour contrasted and do intercoms have accessible features?</p>	D	<p>Entrance gates do not suitably colour contrast and there is no contrast to the controls to aid people with impaired vision.</p>
<div style="display: flex; justify-content: space-around;"> <div style="text-align: center;">

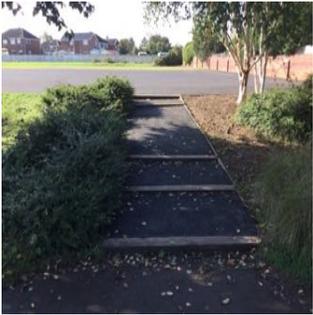
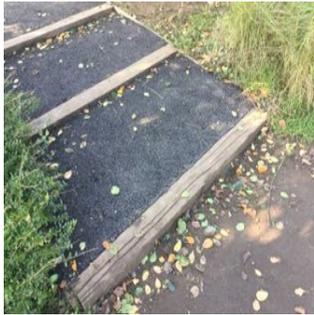
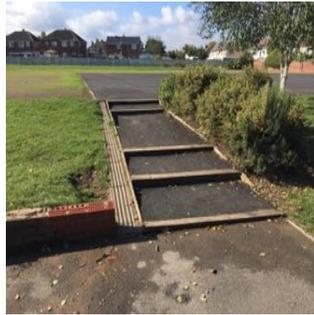
<p>Photo 11</p> </div> </div>		
<p>1.10 - Is there accessible play equipment provided for children with disabilities? Are all key external areas accessible such as forest walks?</p>	A	<p>A new level pathway free of steps needs to be created to gain access onto the upper tier playground area. Both of the stepped routes up should have a free standing handrail provided to one side. Colour contrast also needs to be applied to the edges.</p> <p>Accessible playing equipment suitable for wheelchair users and people with mobility disabilities is something that could be added at a later date.</p>

Item Ref.	Details / Issue	Recommendation	Est Cost	Action Taken
<b>PRIORITY A</b>				
1.10	A new level pathway free of steps needs to be created to gain access onto the upper tier playground area. Both of the stepped routes up should have a free standing handrail provided to one side. Colour contrast also needs to be applied to the edges.	<p>Create a pathway to allow step free access onto the upper tier playground area.</p> <p>Consideration to installing a free standing BS8300 compliant handrail to one side of the stepped routes up. These should be well contrasted and not cold to touch.</p>	<b>OG / M</b>

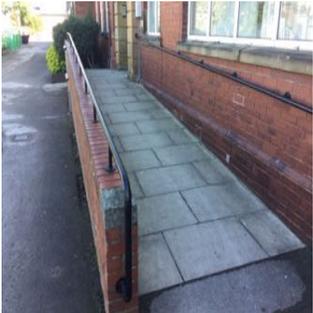
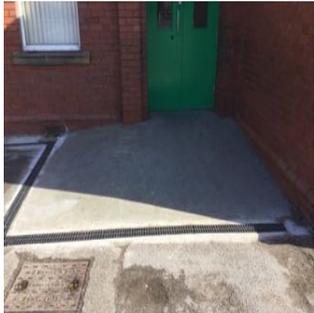
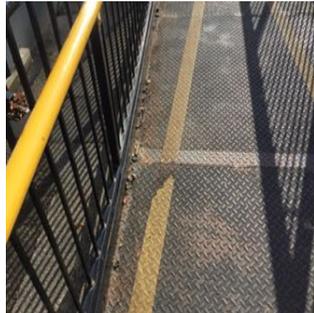
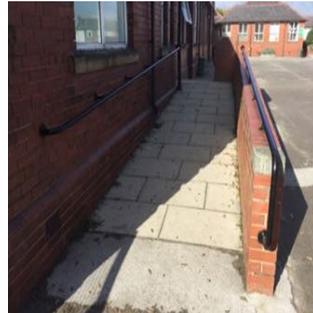
Question	Response	Details
3.1 - Wide enough and suitably graded? Is there colour contrast to the surface of the ramp?	D	<p>The ramps do not have colour contrast to the surface to indicate the presence of a gradient.</p> <p>The ramp up to the mobile classroom has suitable colour contrast however the yellow markings are starting to fade.</p>
<div style="display: flex; justify-content: space-around; align-items: center;"> <div style="text-align: center;">

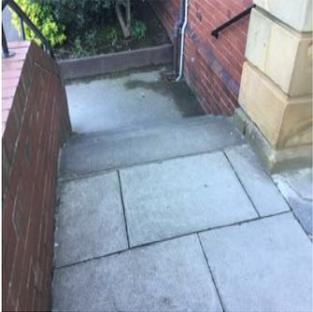
<p data-bbox="264 628 349 651">Photo 21</p>

Question	Response	Details
4.1 - Visual and tactile warnings at the top and bottom of steps?	D	External steps do not feature tactile paving to assist people with impaired vision.

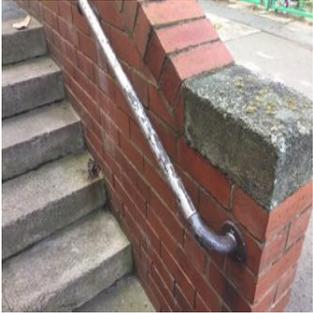
<p data-bbox="264 1331 349 1353">Photo 22</p>

4.2 - Suitable handrails on each side? Are handrails suitably colour contrasted to aid people with impaired vision?	C	<p data-bbox="1267 691 2029 751">The kitchen fire exit steps has handrails which are of exposed metal making them cold to touch.</p> <p data-bbox="1267 788 2069 849">At the Year 4 entrance, there is no grab rail/ handrail provided for the top step.</p> <p data-bbox="1267 885 2078 978">Steps down to the central courtyard need to have new handrails installed. Flights have a handrail to the top step only and because the paint has flaked off they are cold to touch.</p>

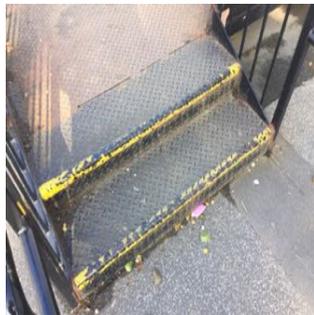
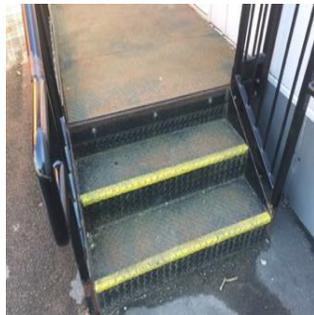
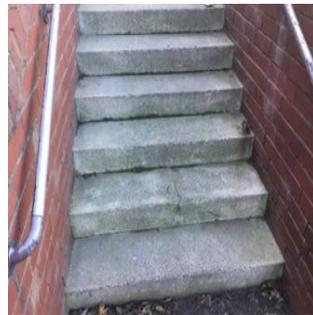
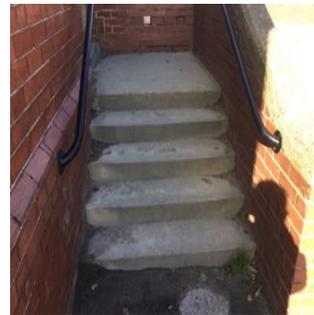
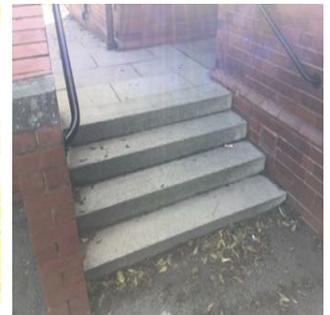
4.6 - Nosings readily identifiable? If nosings are painted, is the paint still durable with no wear and tear?	B	The external steps do not have suitable colour contrast provided to the edge of the step nosings. The steps up to the mobile building require repainting. The left side fire exit steps from the mobile building does not have the top step highlighted.

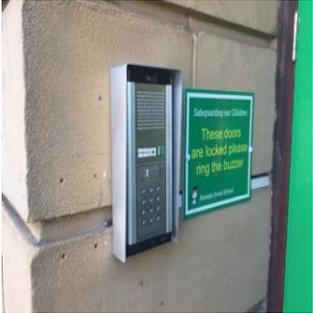
Question	Response	Details
5.7 - Door closer of appropriate type? Can the door be easily opened single handedly?	Yes / N/A	The main entrance has an opening pressure that most should be able to negotiate.
5.8 - Entry phones and intercoms detailed to allow use by people with sensory or mobility impairments? Is there an LED display to accommodate people with hearing impairments?	A	The intercom is positioned too high off the ground floor level for wheelchair users and for people of small stature. The intercom does not have any accessible features such as an LED display to accommodate people with hearing impairments.

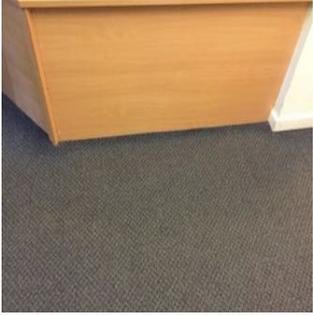
<p data-bbox="264 630 349 651">Photo 41</p>

Question	Response	Details
6.4 - Surfaces suitable? Is there colour contrast to the flooring in front of the reception desk and are edges highlighted?	D	The reception does not have colour contrast provided to the front to aid people with impaired vision.

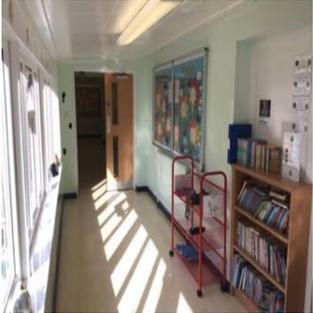
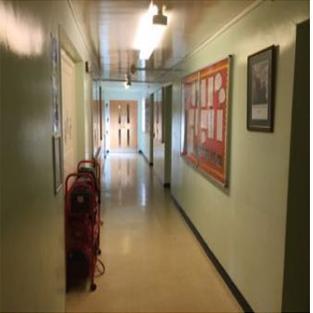
7.5 - Colours, tones and textures varied to help people distinguish between surfaces and fixtures and fittings? Do the floors suitably colour contrast against the walls (this can also be achieved by having well contrasted skirting boards)	C	The colour scheme throughout the school is quite bland with no strong visual clues to aid people with impaired vision. The floors and walls are of a similar colour along with pale wood doors and white frames. The skirting boards are well contrasted.
<div style="display: flex; align-items: center;"> <div style="margin-right: 20px;">

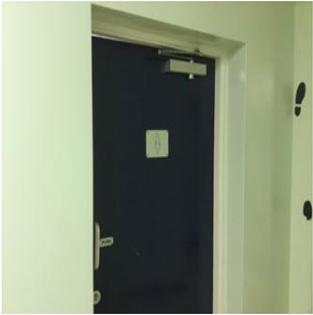
<p data-bbox="264 1409 349 1428">Photo 52</p>

7.7 - Busy or distracting wall coverings avoided?	Yes / N/A	Busy or distracting wall coverings have been avoided.
<b>Checklist 8 - Internal Doors</b>		
8.1 - Distinguishable from surroundings?	C	The colour scheme throughout the school is quite bland. The doors do not stand out visually. Toilet doors are well contrasted against their surround to aid people with impaired vision.

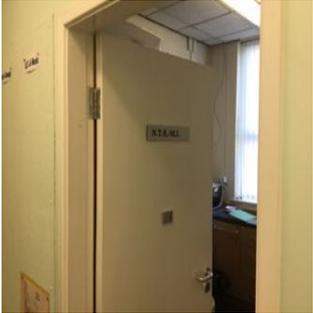
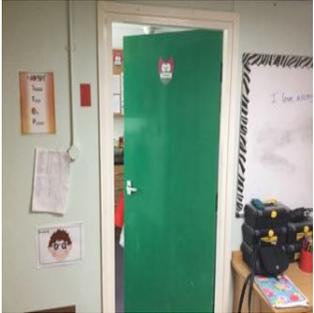
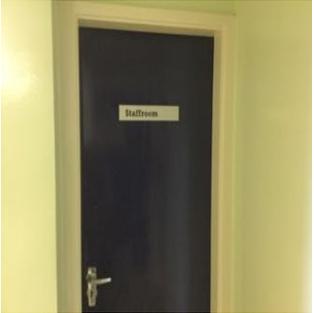
8.3 - Can people each side of the door, either standing or seated, see each other and be seen? Are vision panels kept clear of temporary notices? (for an example classroom entrances)	C	Not all doors have vision panels installed such as the small kitchenette near the Headperson's office.
<div style="display: flex; justify-content: space-around;"> <div style="text-align: center;">

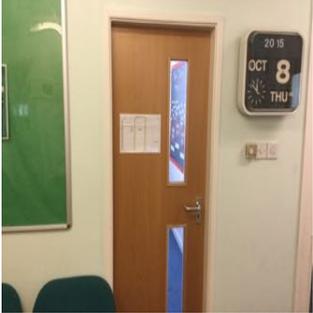
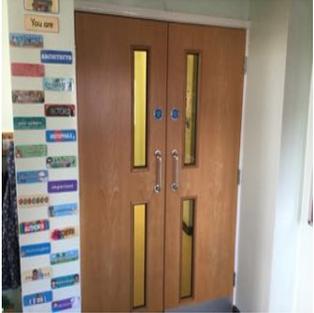
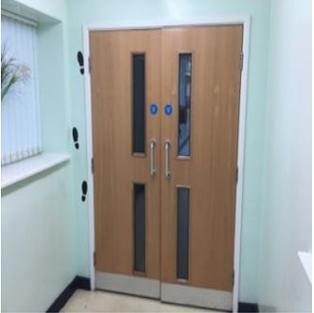
8.4 - Clear opening width sufficient for a wheel chair user? Adequate space available alongside leading edge for a wheel chair user to open the door while clear of the door swing?	A	<p>The meeting room off the main reception area should have the entrance widened. Users of larger wheelchairs may struggle to negotiate it.</p> <p>Throughout the school, many of the double doors are too narrow when a single leaf is opened. When doors are replaced, they should be replaced with a door and a half system.</p>
<div style="display: flex; justify-content: space-around;"> <div style="text-align: center;">

8.4	<p>The meeting room off the main reception area should have the entrance widened. Users of larger wheelchairs may struggle to negotiate it.</p> <p>Throughout the school, many of the double doors are too narrow when a single leaf is opened. When doors are replaced, they should be replaced with a door and a half system.</p>	<p>Where there are double doors, these should be replaced with a door and a half system at the next refurbishment.</p> <p>Widen the entrance to the meeting room off the main reception area.</p> <p>Refer to BS8300 -An effective clear width of less than 800 mm may result in people with poor manoeuvring ability or with large wheelchairs not being able to pass through without damage to themselves or the door. Use of the preferred effective clear width more easily accommodates people with assistance dogs and where there is heavy pedestrian traffic.</p>	M

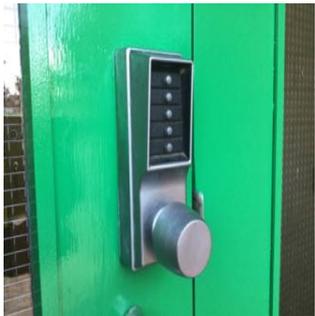
Photo 59

8.7 - Where there are security keypads or readers, are these suitably positioned for potential staff members with disabilities?	D	There is a mixture of keypads used on site and are positioned too high off the ground floor level for wheelchair users. Many people with dexterity impairments can find these difficult to use.

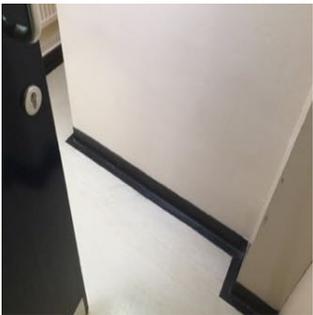
12.1 - Lobby door light enough to open easily? Lobby of sufficient size for easy access?	B	Some toilet lobbies are very tight in size causing manoeuvrability issues such as the male staff WC.
<div style="display: flex; justify-content: space-around;"> <div data-bbox="152 810 465 1125">

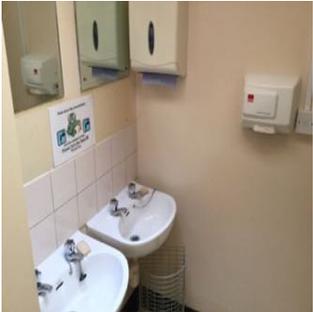
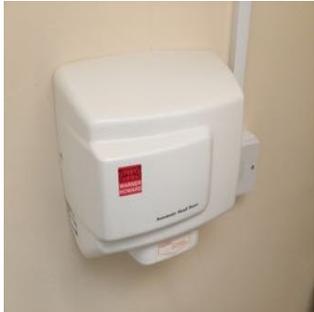
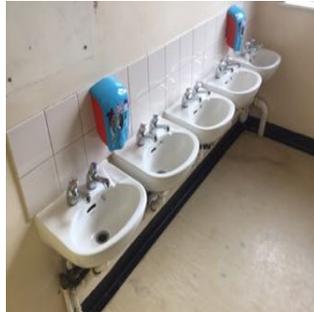
Question	Response	Details
<p>12.3 - Fittings all easily distinguishable from background? Are hand dryers and sanitary ware easily seen against their surroundings?</p>	<p>B</p>	<p>Throughout all of the WCs the colour contrast is poor. The fittings and fixtures are not easily seen against their backgrounds. The colour schemes are bland with no strong visual clues.</p>
<div style="display: flex; justify-content: space-around; align-items: flex-end;"> <div style="text-align: center;">

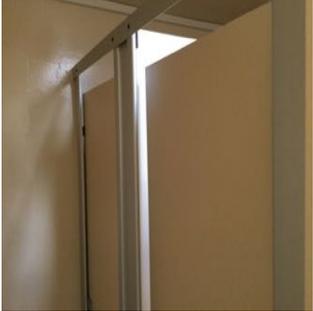
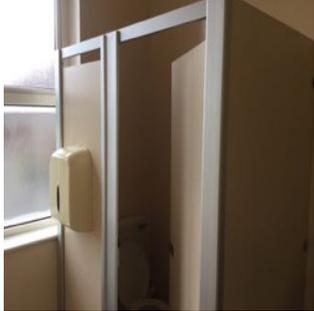
<p>Photo 65</p> </div> </div>		
<p>12.4 - Compartment door controls all easily gripped and operated? Are cubicle doors suitably colour contrasted against the panels?</p>	<p>B</p>	<p>Cubicle doors throughout are not appropriately colour contrasted to aid people with impaired vision. Doors are mainly the same colour as the partitions.</p>

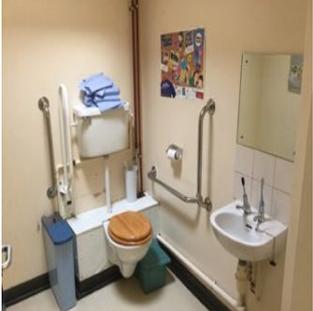
<p data-bbox="264 1211 353 1233">Photo 71</p>

13.1 - Compartment large enough to allow manoeuvring into position for frontal, lateral, angled and backward transfer unassisted and with assistance?	A	The accessible WC requires a complete refurbishment in order to ensure compliance with BS8300. The current facility is outdated and is not really ideal or any longer suitable.

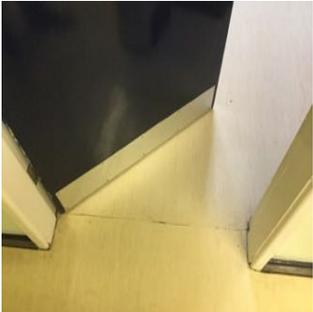
Question	Response	Details
13.3 - Sufficient space available outside toilet compartment for manoeuvre? Is the entrance wide enough and does it open outwards?	A	The accessible WC has an inward opening door which will make it difficult to assist someone within the WC should they stumble and rest against the entrance.
<div data-bbox="152 339 465 651">

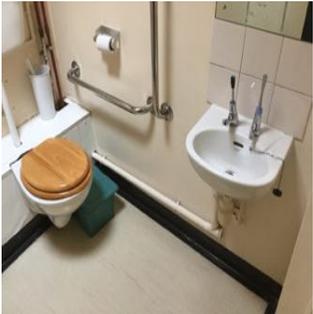
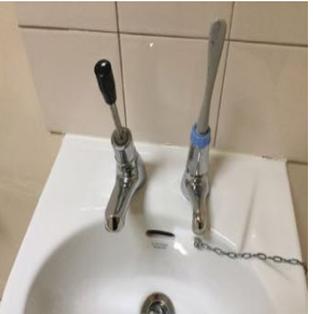
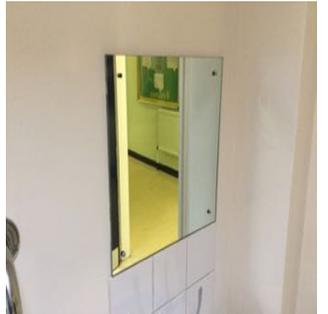
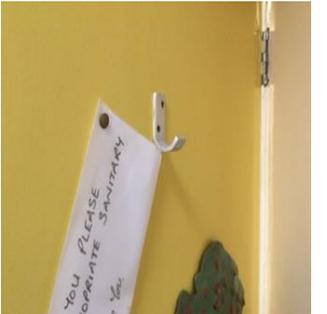
Photo 73	Photo 74	Photo 75	Photo 76

Question	Response	Details	
<p>13.4 - Hand washing and dry facilities within easy reach of someone seated on WC? Is the hand basin suitably positioned in accordance to BS8300?</p>	A	<p>The hand wash basin is positioned too far away from the toilet pan and the taps are dated. It is preferable to have a single lever mixer tap.</p> <p>The mirror is too small and positioned too high off the ground floor level.</p> <p>The door peg is positioned too high on the door.</p> <p>All of the fittings are white seen against a cream background.</p> <p>There is no hand dryer available.</p> <p>There is no soap dispenser.</p> <p>The toilet seat is currently loose and not appropriately attached.</p>

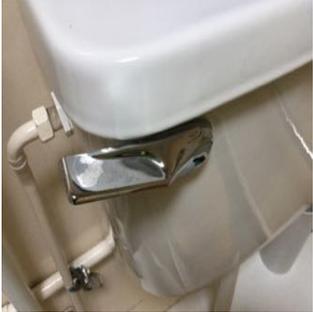
Question	Response	Details
<p>13.9 - Is the flush of a suitable spatula type and is it appropriately located on the transfer side of the toilet pan?</p>	A	<p>The flush is not of spatula style however it is located on the correct side of the toilet pan.</p>
<div style="display: flex; align-items: center;">

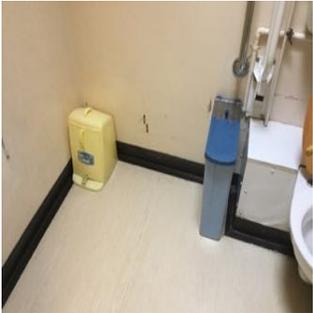
<div style="margin-left: 10px;"> <p>Photo 80</p> </div> </div>		
<p>13.10 - Is the transfer side of the toilet pan kept clear of any obstacles that may deny wheelchair users all of the transferring techniques in which an accessible WC is designed to provide?</p>	A	<p>On the day of the survey, the sanitary bins were stored within the transfer area of the accessible WC denying wheelchair users the appropriate transferring techniques in which an accessible WC is designed to provide.</p>
<div style="display: flex; align-items: center;">

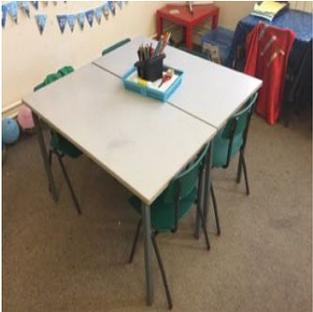
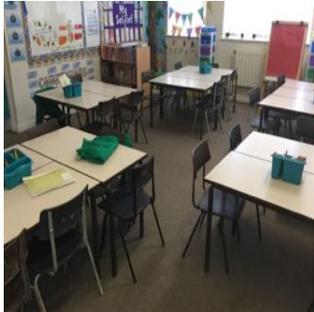
Question	Response	Details
14.3 - Are a number of chairs with armrests available within each learning space?	C	Classrooms do not have chairs with armrests to aid people with ambulant disabilities. Some classrooms have seats which are the same colour as the flooring such as 4YS.
<div style="display: flex; justify-content: space-around;"> <div style="text-align: center;">

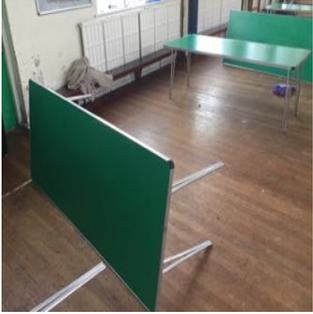
Question	Response	Details
14.6 - Do the dining / cafe areas have appropriate seating rather than fixed seating which can be inaccessible for a range of users?	Yes / N/A	Non fixed seating is provided for dining times which is easily movable and adjustable. Some schools are now installing fixed pull out seating/tables which can be problematic as they are not very flexible and do not feature armrests.

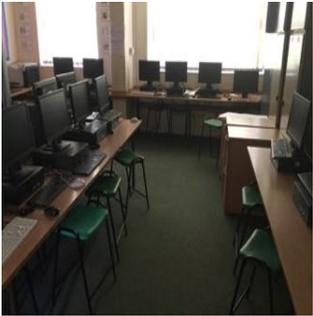
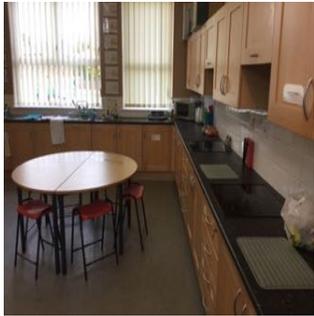
Question	Response	Details
<p>14.8 - Where there are IT facilities or break out study areas are height adjustable computer desks available?</p>	<p>C</p>	<p>There are no height adjustable tables provided to accommodate wheelchair users and people of short stature. This is something that could be provided once it is a specific requirement such as a pupil who requires the use of a wheelchair.</p> <p>At the next refurbishment for the cookery room consider a height adjustable work/cook station for wheelchair users or for people of short stature.</p>
<div style="display: flex; justify-content: space-around;"> <div style="text-align: center;">

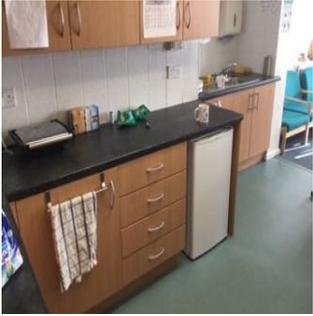
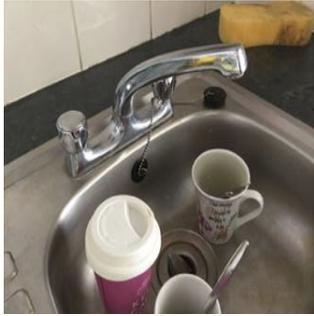
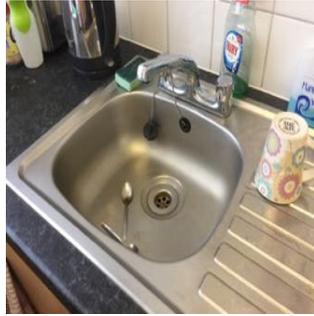
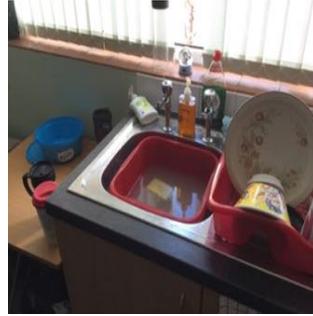
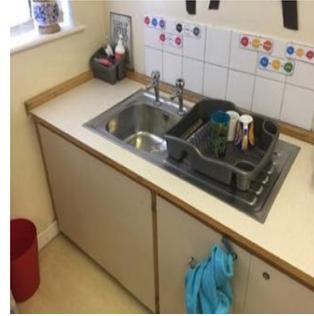
<p>Photo 88</p> </div> </div>		
<p>14.9 - Do staff and general kitchenette areas have a lever tap to accommodate people with dexterity impairments? Are there split height work surfaces available?</p>	<p>D</p>	<p>The kitchenette within the staff room does not feature lever taps to aid people with dexterity impairments. Further kitchenettes require lever taps installed.</p> <p>Taps within classrooms should be changed to lever style to aid people with dexterity impairments.</p>

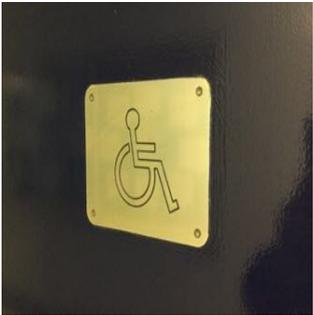
<p data-bbox="264 1031 353 1054">Photo 94</p>

15.3 - Are standard toilet facilities suitably signed? On approach and on the actual entrances? Are the locations of the accessible WC facilities suitably identified and located? Does signage have the International Symbol of Access? (Wheelchair symbol)	B	There is a lack of signage to indicate where the toilets are located, there is no tactile or Braille signage provided on the toilet doors.

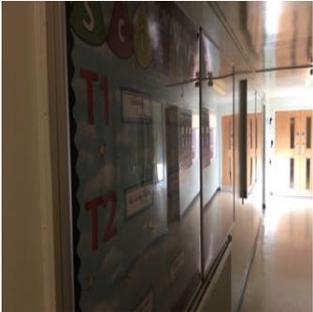
<p data-bbox="264 659 353 683">Photo 95</p>

Question	Response	Details
15.6 - Are notice boards well structured and the use of reflective protective covers avoided? Are temporary notices illustrated using good practice i.e. use of lower and upper case lettering?	D	Many of the noticeboards have a reflective surface making the information difficult to read due to glare.

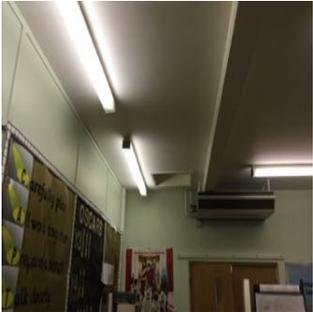
Question	Response	Details
<p>16.2 - Lights positioned where they do not cause glare, reflection, confusing shadows or pools of light and dark?</p>	<p>B</p>	<p>Lighting throughout the corridors and select learning areas appears to be uneven and dark. Many areas have an unpleasant yellow hue.</p>
<div style="display: flex; justify-content: space-around; align-items: flex-end;"> <div style="text-align: center;">

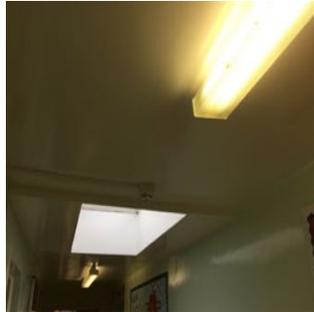
<p>Photo 98</p> </div> </div>		
<p>16.3 - Can occupiers control lighting? Are light switch plates suitably colour contrasted and appropriately positioned for a wheelchair user?</p>	<p>D</p>	<p>The majority of the light switch plates are not suitably colour contrasted against their background.</p> <p>Sensor lighting should be considered for throughout the school which is not only energy efficient but also far more accessible than light switches that may not colour contrast against the walls or be positioned at awkward heights for wheelchair users.</p>

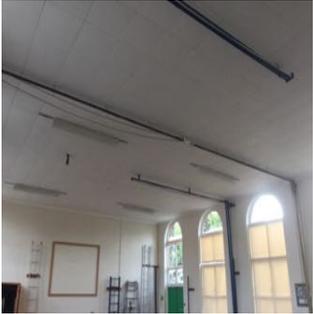
<p data-bbox="259 794 353 815">Photo 103</p>

16.8 - Are induction loops fitted within the key areas i.e.- Main Hall	A	There is no induction loop provided within the main hall or gym to aid people with hearing impairments. These parts of the school are areas in which visitors can frequent such as for performances.

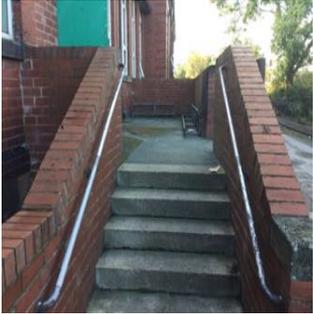
17.2 - Ground floor exit routes accessible to all, including wheel chair users, as entrance routes?	A	There is no level egress available from the kitchen fire exit as it leads to a platform then steps.

Question	Response	Details
<p>17.3 - Once outside, can a wheelchair user get to a place of safety? Are pathways provided and are these wide enough?</p>	A	<p>The fire exit from the kitchen leads directly to a platform in which wheelchair users would not be able to evacuate from.</p> <p>Once outside, wheelchair users are able to get to a place of safety. The pathways from the school are sufficient to allow appropriate manoeuvrability for wheelchair users.</p>
<div style="display: flex; align-items: center;">

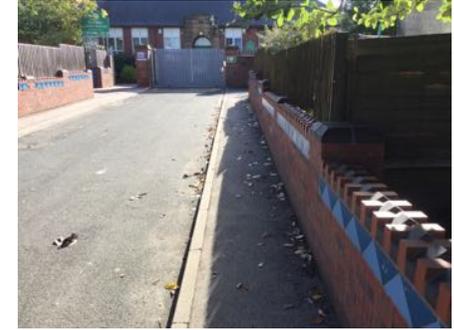
Photo 4

<p>Photo 4</p> </div> </div>		
<p>1.4 - Surfaces even and slip resistant? Is paving flush with no cracks or gaps that could trap the wheels of a wheelchair?</p>	<p>Yes / N/A</p>	<p>Various parts of the external routes have tripping hazards identified such as just before the right side gate.</p>

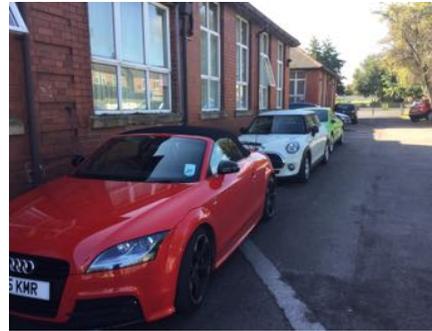
Photo 15

Question	Response	Details
2.1 - Are accessible bays provided for badge holders?	A	There are no accessible parking spaces marked out within the car park for Blue Badge holders.
<div data-bbox="152 308 465 622" data-label="Image"> </div> <p data-bbox="264 630 353 651">Photo 15</p>		
2.2 - Accessible bays clearly sign-posted from the sites's car park entrance? Is there signage to the front of the bays?	Yes / N/A	Not currently applicable for this school.
2.3 - Are bays marked out appropriately and easily identified? Can car doors be fully opened to allow disabled drivers and passengers to transfer to a wheel chair parked alongside?	Yes / N/A	Not currently applicable for this school.
2.4 - Close enough to facilities the car park serves?	Yes / N/A	The parking spaces are located within the immediate vicinity of the main entrance.

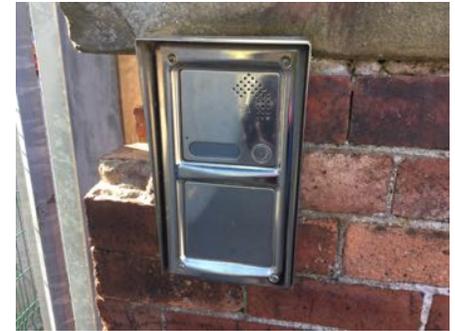
Photo 16

Question	Response	Details
2.5 - Routes from parking area to site entrance accessible, with dropped kerbs and appropriate tactile warnings? Car park surface smooth, even and free from loose stones?	B	<p>At current people would need to exit their vehicle upon arriving at the school gate to speak on the intercom. This is likely to cause potential difficulties for wheelchair users. The intercom does not have an LED display to accomodate people with hearing impairments.</p> <p>The approach to the entrance from the parking spaces is all accessible for those unable to negotiate steps.</p>
<div data-bbox="150 501 465 815" data-label="Image"> </div> <p data-bbox="264 823 349 842">Photo 16</p>
